FISH PASSAGE

STILLING BASIN REHABILITATION BULL RUN DAM NO. 2 – WALKER CREEK FISH PASSAGE CULVERT CITY OF PORTLAND WATER BUREAU, OR

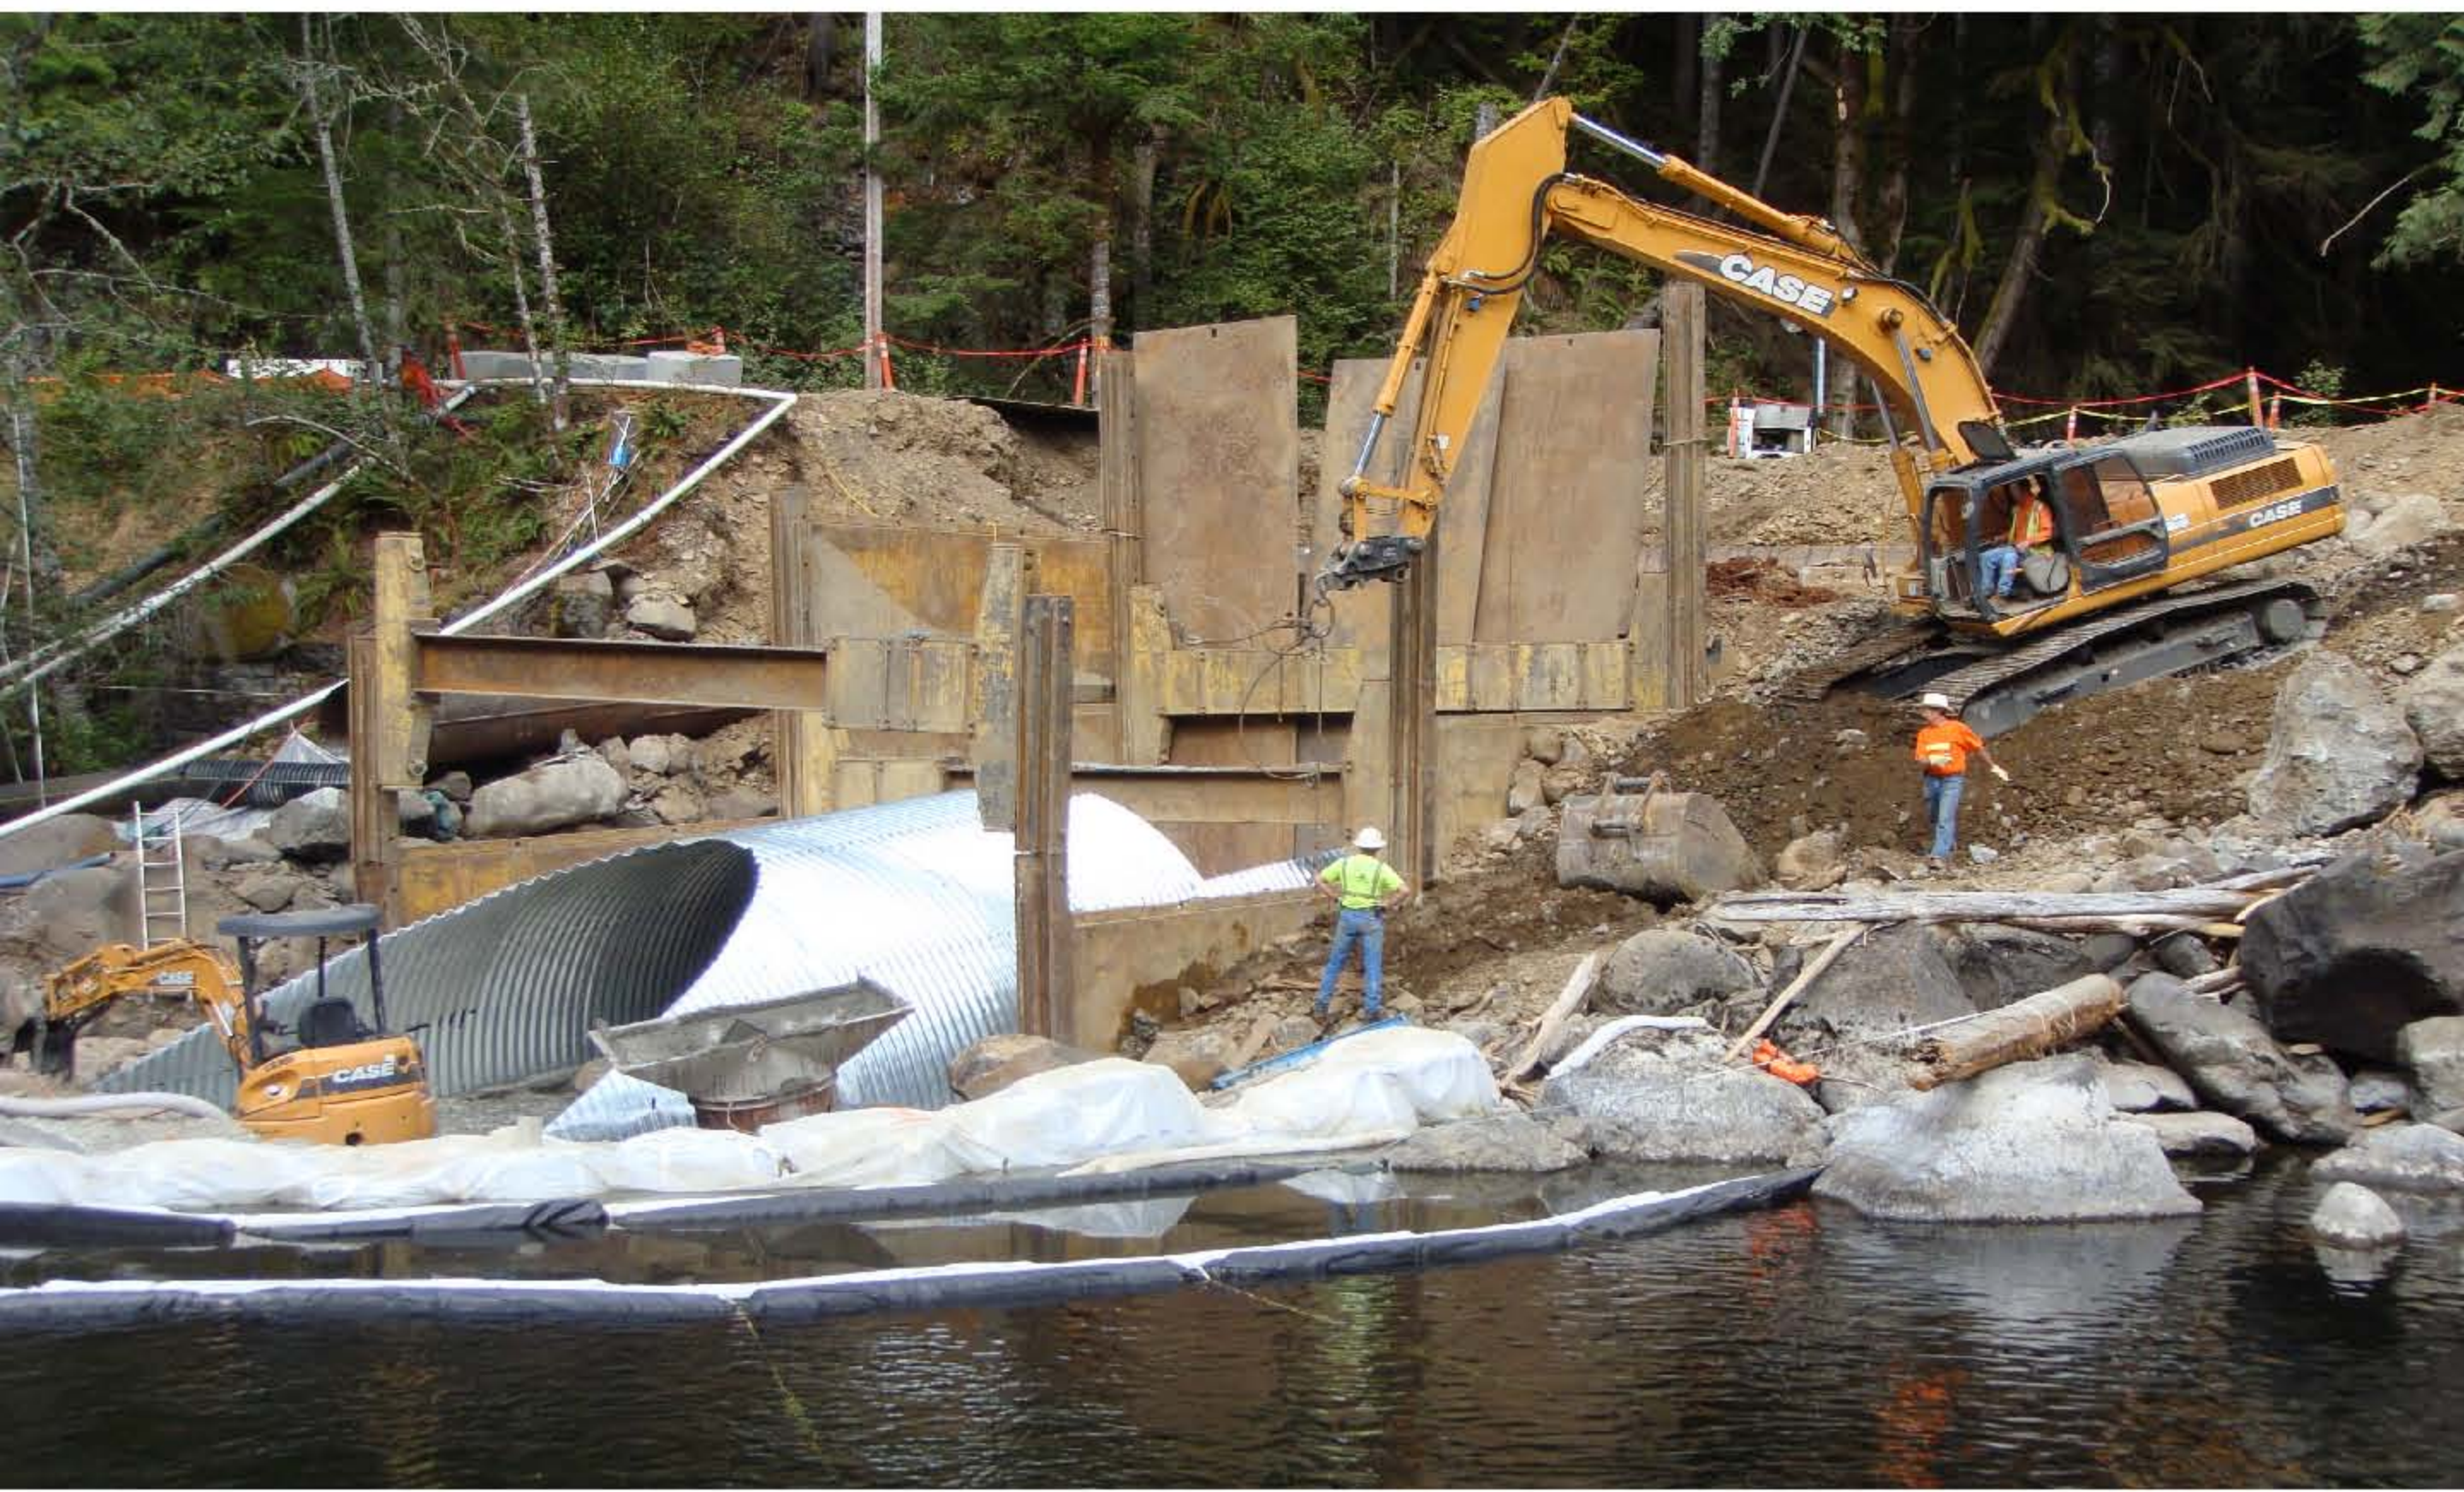
- 18.5-foot wide open bottom arched culvert design to replace existing 52-inch diameter culvert
- Culvert construction under existing 52-inch and 66-inch diameter water conduits No. 2 and No. 4
- Channel restoration to natural stream conditions
- Jumping pools for fish passage enhancement
- Project completed concurrently with the removal of existing upstream culverts and channel restoration

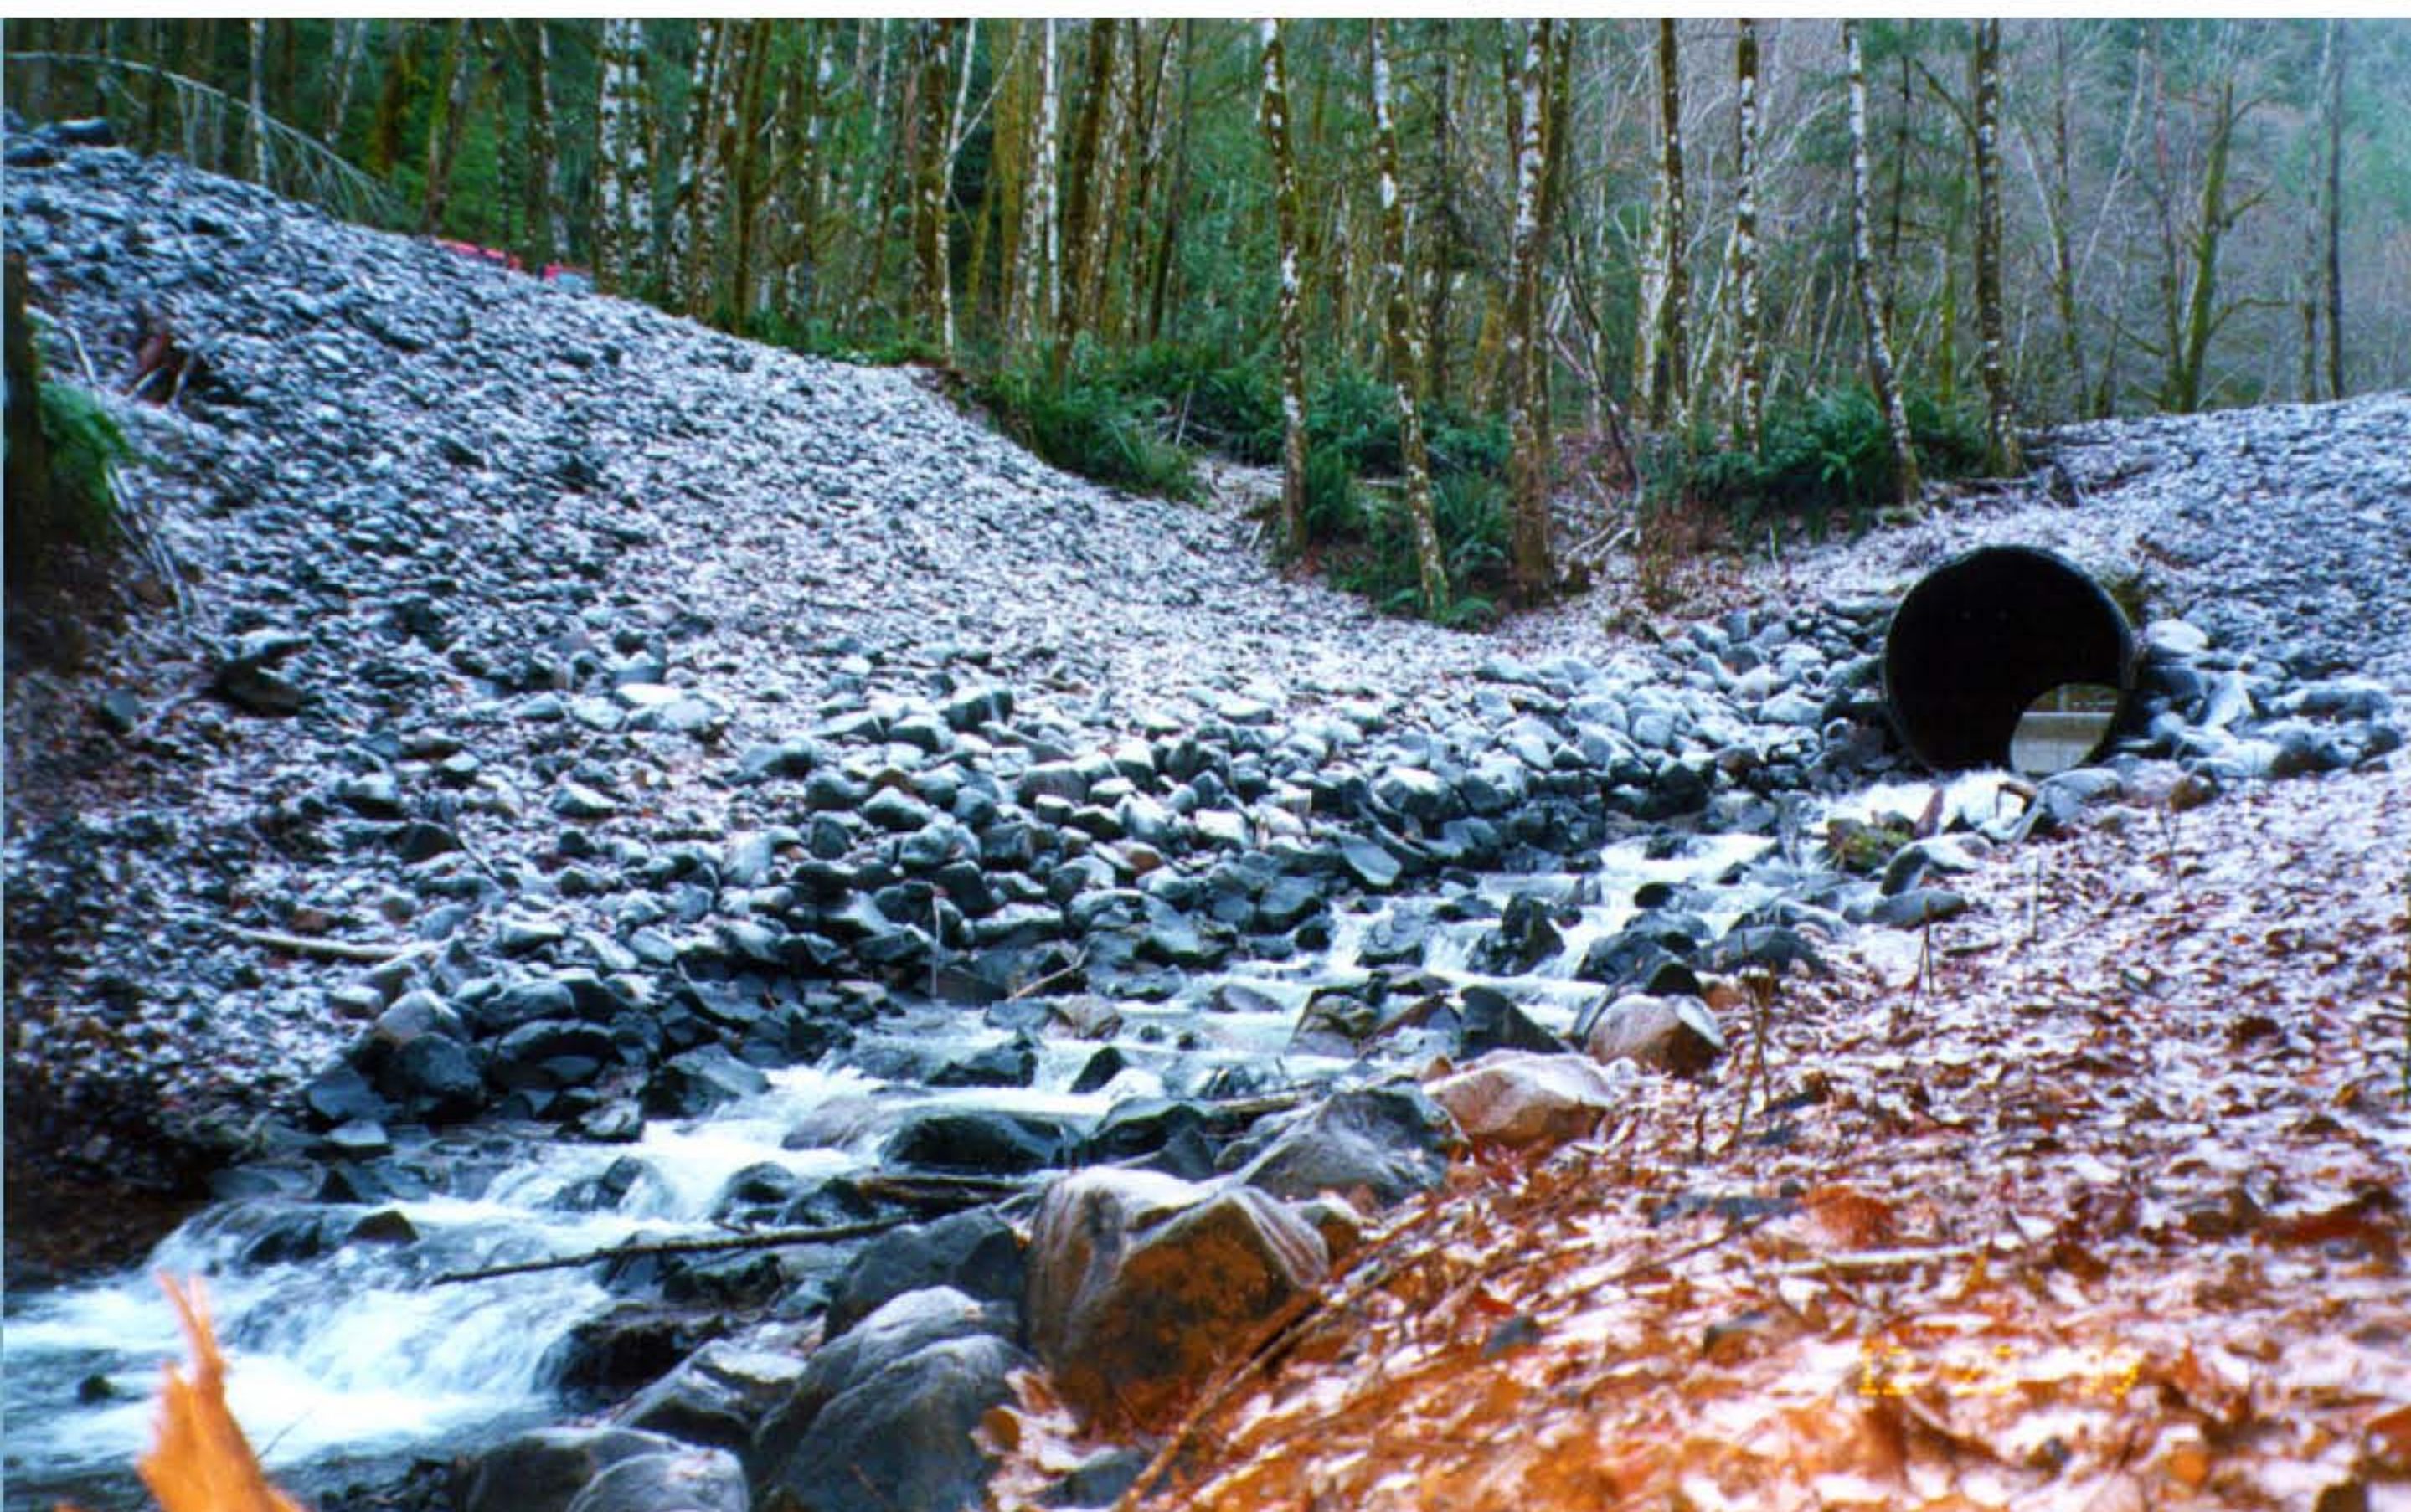
IDLEWILD CREEK FISH PASSAGE IMPROVEMENTS, MCMINNVILLE WATER AND LIGHT, OR

- Jumping pools added to downstream side of existing six-foot diameter culvert
- Restored fish passage by removing 13-foot drop
- Accommodates fish passage through wide range of flows
- Jumping pools designed to provide resting places for small fish
- Drops accommodate juvenile fish jumping ability
